# Elton Backchannel

**Location:** Elton, Peterborough

## Background to project

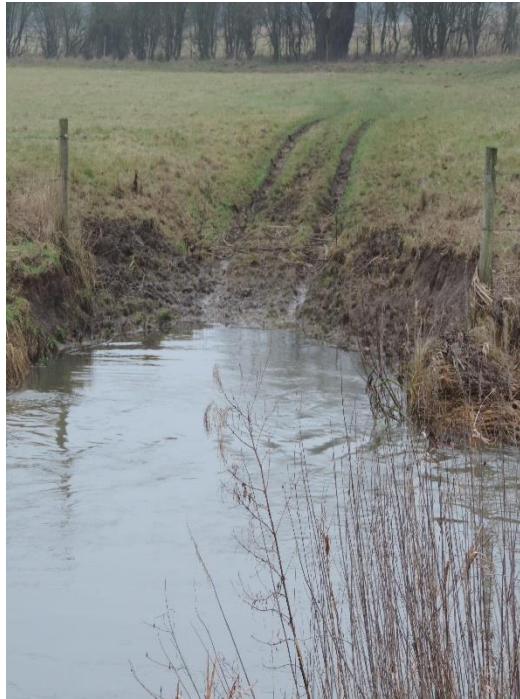
However, in the winter and after prolonged rain the ford and surrounding land become waterlogged and heavily poached and this results in significant introduction of fines sediment. The riverside fencing, particularly on the right bank, was also in poor condition and had collapsed in several places. This allowed the cattle to access the riverbank and wet berms and they were overgrazing and poaching the marginal wetlands.

*Figure 2 Elton ford prior to this project*

Remedial work was completed on the ford to reduce fine sediment and nutrient inputs as a result of cattle crossing and congregating on the ford. The eroded ramps sides and the ford ramps were stabilised by re-profiling them to reduce the angle of the batter by having a base layer of 100-150mm of granite laid down with a top layer of 4-20mm of crushed granite being ‘tracked in’ after. This provides the cattle with a comfortable base to walk on when they are moved across the channel and the ramps were grass seeded after. The granite was placed no further than the face of the bank. The ‘wet’ bed of the ford was not be re-stoned to minimise further mobilisation of fine sediment.

A 360 tracked excavator with a suitable reach, operated by a qualified driver was used to carry out this work. “Clean” stone was specified to minimise the introduction of fine sediment to the water course. Stone was delivered by lorry to the ford. Prior to placement the stone was thoroughly re-washed using river water poured from the excavator bucket leaving any residual fine sediment on the bank. Figures 2

and 3 show a before and after comparison of the remedial work on the ford. The new ford is now suitable for cattle to cross with the newly lined ramps and the re-profiled banks.

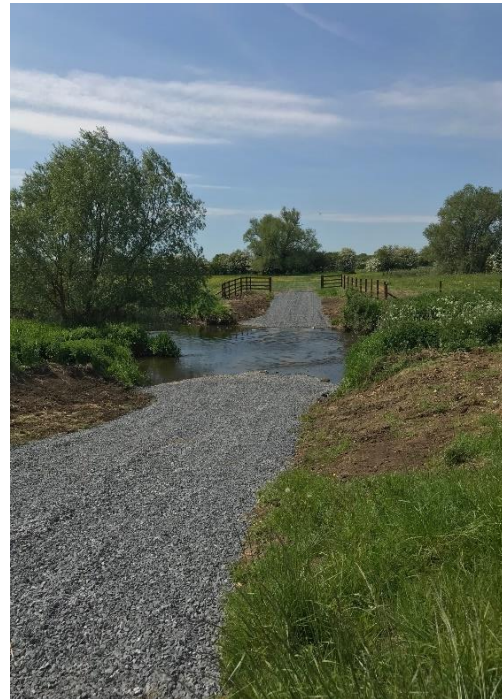
*Figure 3 Elton ford after the works had been completed*

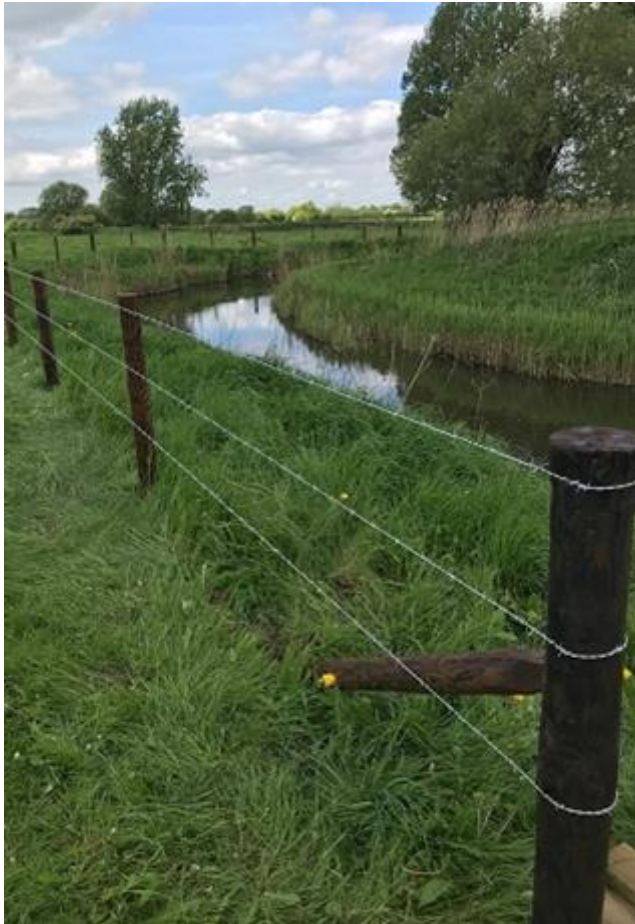
*Figure 4 New fencing installed at Elton*

The post and barbed wire fencing was previously in poor condition on the right bank and in places had collapsed. A new fence line was erected 1m back from the original line, the fencing was upgraded to 3

strands of barbed wire to minimise cattle damage and reduce the likelihood cattle would attempt to breach it. Angler access points were upgraded from a “pipe” crossing to a simple treadless post and rail stiles. Heavy duty post and rail fencing at the top of the banks either side of the ramps that lead down to the ford were erected and access gates were installed to prevent cattle access. Overall, over 600 metres of fencing was erected.

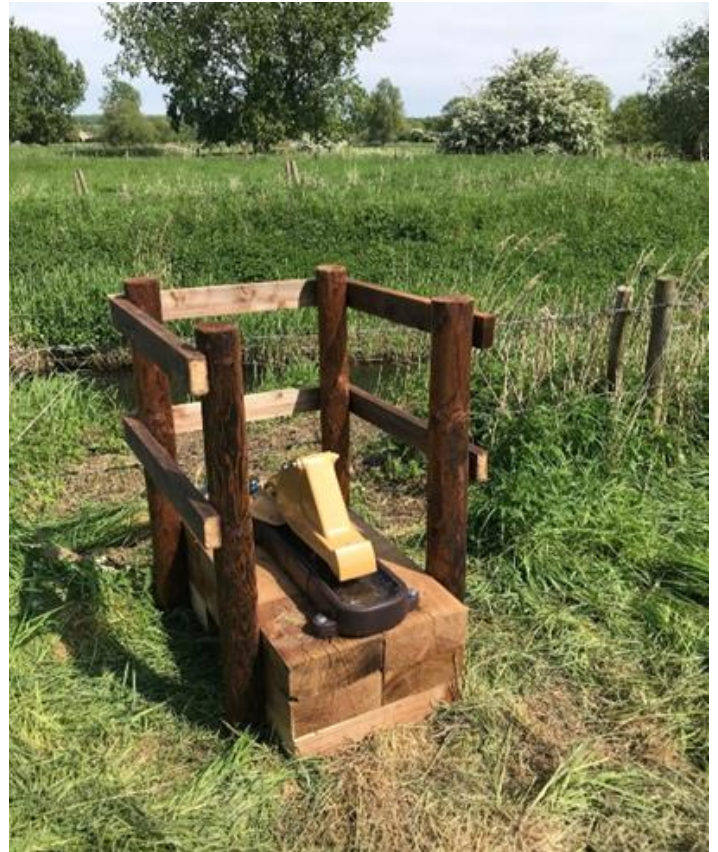
*Figure 5 One of three pasture pumps installed at Elton*

Due to the fencing of the ford and new fence line running along the length of the river a new water supply was required on the left-hand bank. Three pasture pumps were installed for the cattle to drink from as this was deemed the most efficient method of providing water for the cattle. These devices are a very low maintenance way of providing water for cattle as the cattle operate them by pushing the pump with their nose as they drink from the small trough.
